Cast Iron Pipe Failure: Elements of a Forensic Investigation

Donald Dunn¹; and Ralph E. Moon, Ph.D²

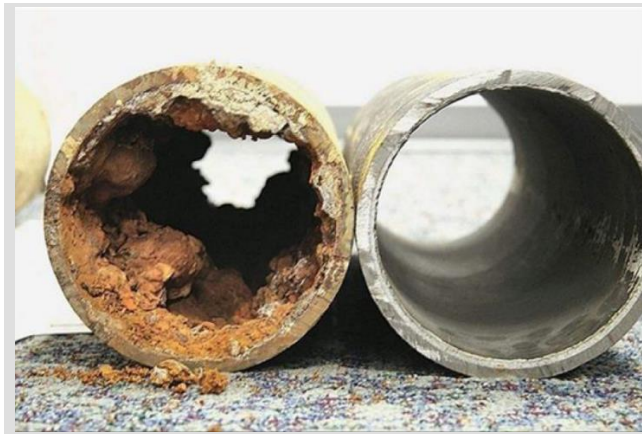
CIP Failure: Cast iron sanitary drainpipe is referred to as high carbon content gray cast-iron. When a high-carbon cast-iron pipe corrodes it forms an insoluble graphitic layer. These corrosion products are very dense and form a barrier against further corrosion. In tests of a severely corroded cast-iron pipe, the graphitic corrosion product has withstood pressures of several hundred pounds per square inch even though the corrosion had penetrated the pipe wall (**Photo 1**) (CISPI handbook).

Corrosion Analysis: The most common change inside CIP is tubercle formation. Tubercles are formed from ferrous oxide in the water not CIP corrosion (Larson and Skold, 1957). Rather than the pipe materials being “removed” as occurs with corrosion, the tubercles are biologically deposited on the pipe walls. The tubercle begins with bacteria that form a bacterial slime layer that incorporates manganese and iron in the water. The slime layer accumulates over time, and the reddish-brown products solidify and reduce the interior pipe diameter and flow capacity. Tubercle thickness inside a pipe does not reflect the extent of pitting on the pipe wall surface. The tuberculation and accumulation can be removed by proper cleaning without affecting the pipe’s structural integrity. When investigating CIP failure, consider the contribution and extent of the type of corrosion present in the pipe. Galvanic, pit, microbial, erosion, graphitic, stress crack related, or corrosion may require different investigative approaches. Consider the influence of municipal water chemistry, native soil conditions, or the changes induced by stray electrical currents.

Photo 1: An example of graphitic corrosion with distinctive tubercle formation

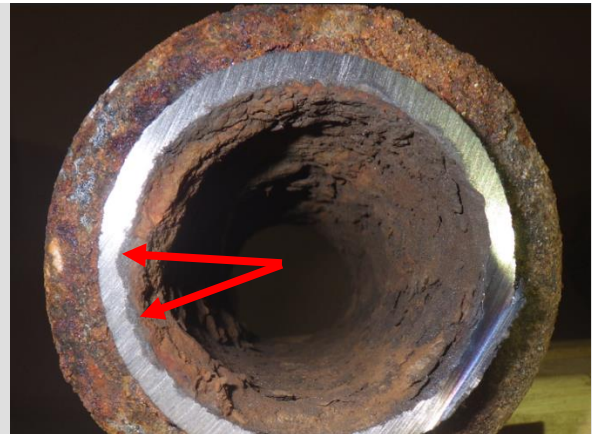
Photo 2: Arrows point to graphitic corrosion that penetrated the pipe wall

Graphitic Corrosion: This is a form of galvanic corrosion that occurs in wet or moist environments where water acts as an electrolyte and allows a weak electrical current created by dissimilarities in the iron and graphite to remove the iron from the more cathodic graphite (Logan *et al.*, 2014). The arrows identify where the graphitic corrosion has penetrated the pipe wall (**Photo 2**). When the accumulated material on the pipe interior is removed, the exposed graphitic material has a grayish-black irregular glassy finish. As the graphitic corrosion continues over an extended period, the pipe will eventually lose its structural integrity and be subjected to erosion corrosion.

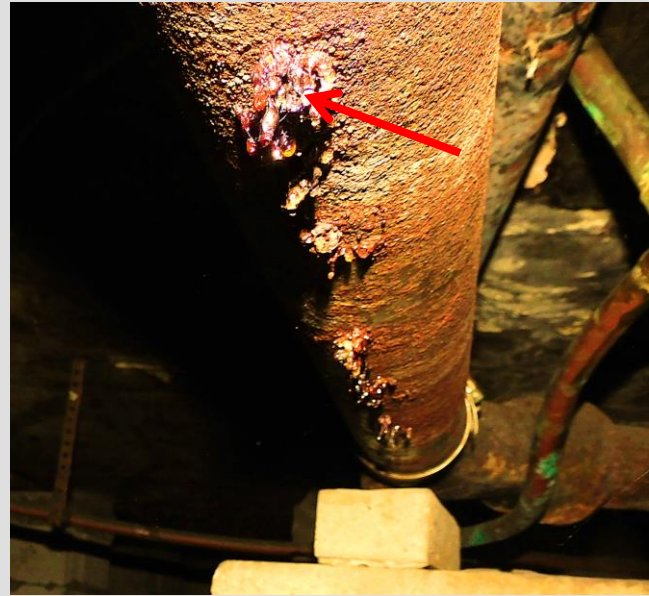
Pinhole Corrosion: This type of galvanic corrosion occurs where the corrosion cell is localized to an unprotected area of the pipe. Corrosion will progress until the pipe is penetrated and can be seen on the outside (**Photo 3**). This corrosion usually precedes other types of CIP corrosion. Water from a sanitary system that escapes the pinhole leak will contribute nutrients to the surrounding soil and encourage bacterial growth and biomat formation.

Photo 3: Pinhole corrosion is localized to a particular unprotected area of the pipe

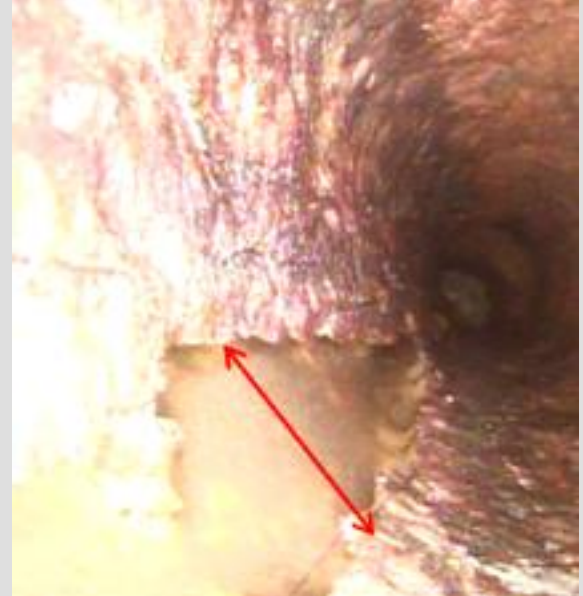
Photo 4: Erosion corrosion occurs when turbulent flow erodes the pipe bottom

Erosion Corrosion (EC): This is a consequence of turbulent water flow that erodes the bottom of the pipe at a greater rate than the sides (**Photo 4**). Erosion corrosion also exacerbates graphitic corrosion as the graphite that's left after the leaching of the ferrous material has progressed to the point where the softer graphite is more impacted by the turbulent flow. This is a very long-term event and is not representative of a sudden catastrophic failure of the cast-iron pipe. The EC rate is accelerated by turbulent flow. EC creates thinning along a narrow area along the bottom of the pipe (**Photo 5**). Thinning creates local areas of increased turbulence that increases the corrosion rate. The EC process leads to “channel rot” which causes holes and breaches on the bottom of the pipe as EC progresses.

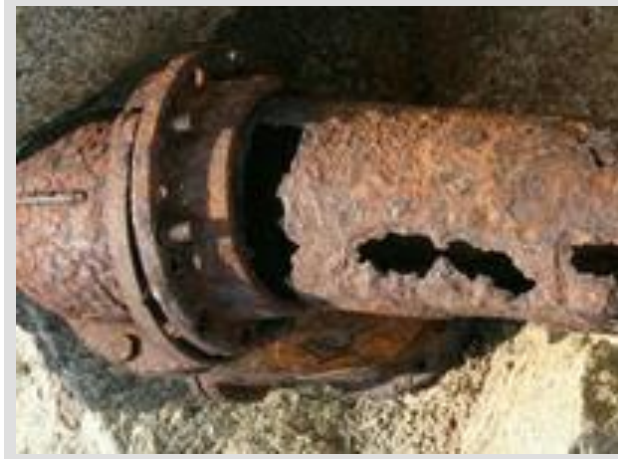
Photo 5: Erosion corrosion and channel rot

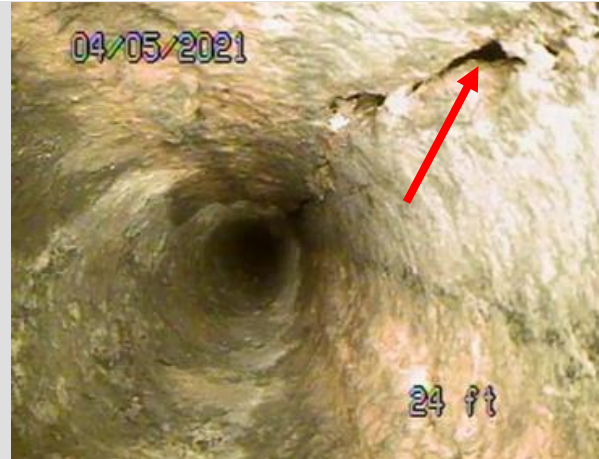
Stress Crack Corrosion: This corrosion can occur due to several different factors including latent manufacturing defects, material handling, and installation errors as well as from a slow progression of environmentally induced corrosion over time combined with mechanical stress and corrosion reactions (**Photo 6**).

Photo 6: Stress crack corrosion
