CLEANING SCIENCE QUARTERLY

Floor Tile Movement: The Effects of Temperature and Liquid Water Exposure

N. Wells, P.E., R. E. Moon, Ph.D., D. Nehrig, E.I. and R. Mulcahy

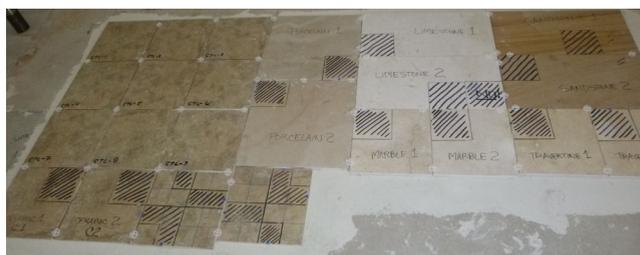
Photo 1: Various types of tile with select sizes of wax paper positioned beneath each tile and controls of nine ceramic tiles.

Tiles of varying bonding coverage were prepared using random layouts of an inserted substrate (wax paper) to simulate 10, 25, 50, 75, 85 and 90% coverage. One-hundred percent mortar coverage controls were prepared without the use of inserted substrates. Each adhesive configuration was replicated to comprise 60 unbonded configurations and nine controls. The broad range of tile bonding percentages was implemented to represent real world scenarios where the tile installers often do not conform to Tile Council of North America (TCNA) standards.

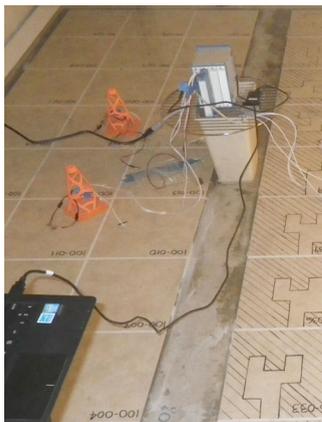
Photo 2: Preparation of floor tiles equipped with strain gauges and thermocouples before flooding.

insulation and sealant applied to the floor and butted ends to create a watertight border approximately 3 inches in height (Photos 2 and 3).

Four strain gauges and four thermocouples were affixed to selected tiles to monitor temperature change and movement continuously during testing. The water-tight border was flooded with ambient temperature water (80°F) for 48 hours, drained and the tiles checked for debonding by tapping (ASTM E1007) immediately after draining. The area was flooded again with hot water (120°F) directly from the base of a water heater and tiles subsequently tested again for bonding. A sudden water intrusion event can occur in several scenarios such as a water heater failure, flooding from the exterior, pipe burst, roof leak, etc. This test was conducted to simulate a worst-case scenario.

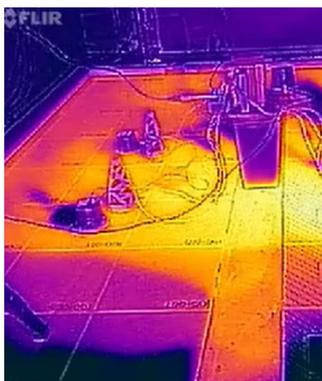
Photo 3: FLIR image of hot water (120°F) being discharged over floor tiles.
