**FORENSIC  
ENGINEERING  
8th CONGRESS**

## Elastomeric Coatings: A Qualitative Failure Analysis

N. Alrafie<sup>1</sup>; R. E. Moon<sup>2</sup>; and M. Bass<sup>3</sup>

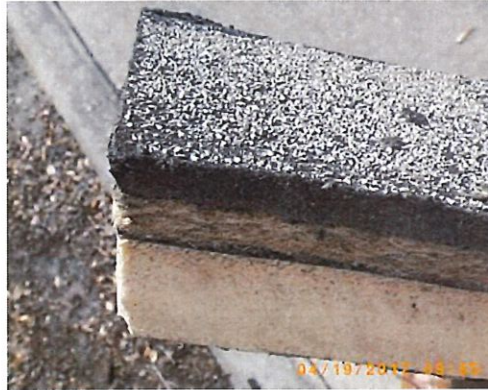
**Photo 1: Cross section and appearance of a BUR that was not coated in the energy savings program (Photo by Ralph Moon).**

Energy-saving incentive programs initiated in the mid 2000 promoted the application of a white acrylic elastomeric coating on sloped and flat roof systems for building owners and multi-family condominium structures. The program was based on projected energy savings that white-coated roof systems would reflect as much as 73% of the sunlight, absorb less radiant heat and allow the recipient the benefit of lower energy costs. The most common roof systems in the program were “built up roofs” (BUR) that consisted of several layers: insulation, fiberglass reinforced asphalt (bituminous) membrane and mopped hot asphalt followed by a top layer of rolled asphalt roofing (**Photo 1**).

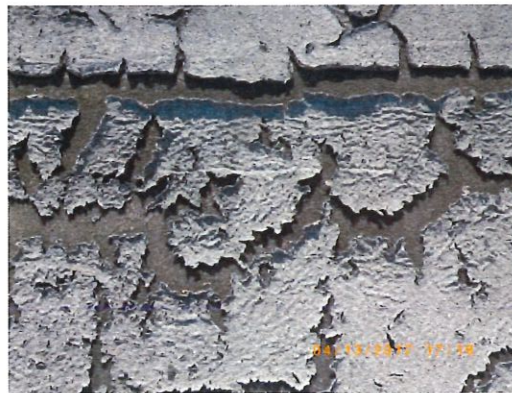
**Photo 2: BUR systems of similar age and construction that were coated experienced visible damage and separation of the stone aggregate (Photo by Ralph Moon)**

A few years after the program matured, it was discovered that roof systems applied with the white elastomeric coating experienced partial to complete removal of the upper stone aggregate from the underlying asphalt layer; non-coated roofs experienced no aggregate removal. The exposed stone aggregate surface exhibited “alligatoring” with characteristic cracking, curling and

peeling (**Photo 2**). In contrast, BUR systems that were not treated with the white elastomeric coating exhibited uniformity in the distribution of granular stone aggregate five years or more after similar roof systems that were coated with the white elastomeric coating had failed.

Among the damaged roofs, the areas that exhibited the most profound removal of the upper stone aggregate were those where water had ponded. These findings prompted an examination of the effects of heat, submersion in water and cyclical wetting and drying of the elastomeric-coated surfaces in an effort to understand the circumstances that prompted the damage.

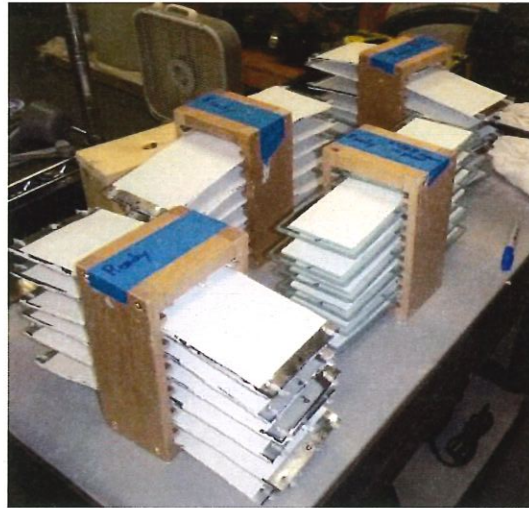
Photo 5: Four sets of specimens in oak rack following coating application before testing

The specimens (single and attached) were divided into four identical test groups consisting of 4 glass specimens, 4 metal to flat asphalt specimens and 4 metal to granulated asphalt specimens (Photo 5). A fifth control group consisted of one glass, one metal, one flat asphalt and one granulated asphalt with coatings applied as described above.
