Wood Flooring: Recognizing Water Damage

By Nolan Wells, Ralph E. Moon, PhD and Donald Nehrig

This study examined wood flooring exposed to two moisture-exposure scenarios: 1) damp concrete to reveal changes in surface appearance, mold growth and cupping; and 2) partial water immersion to reveal the occurrence of thickness swelling and surface distortion. The responses of the four predominant wood flooring types — hardwood, engineered hardwood, laminate and bamboo — were compared

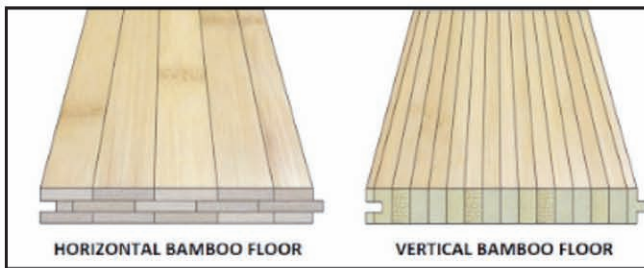
Figure 4. Horizontal and vertical bamboo flooring orientation. Source: BambooFloorCompany.com, a trading name for Kitchner Flooring LTD.

- *Bamboo flooring.* The most common species of bamboo for flooring is Moso Bamboo (*Phyllostrachys edulis*). Bamboo is in the grass family because it grows laterally using rhizomes. Bamboo flooring may be constructed in a horizontal or vertical orientation with a characteristic linear grain. During manufacturing, bamboo flooring is divided into long strips that are boiled and dried to remove starch, insects, and sugars. The strips are glued together to form flooring planks as thick as the width of the strips (Figure 4). Bamboo flooring is known for its strength; however, the strand-woven bamboo comprised of shredded bamboo fiber is the strongest. In the strand woven manufacturing procedure, the bamboo is treated as above to produce a pulp that is placed in a mold and pressed under extreme

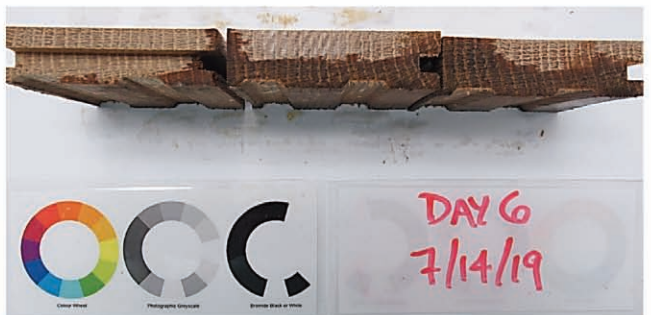
Photo 2. This hardwood flooring exemplar (rift sawn) (Day 6) was the only exemplar that did not exhibit cupping after 142 days exposure to damp concrete.

The hardwood flooring exemplar that did not exhibit cupping was rift sawn (Photo 2). The rift sawn method is a premier cut that minimizes wood distortion in wet or humid conditions.

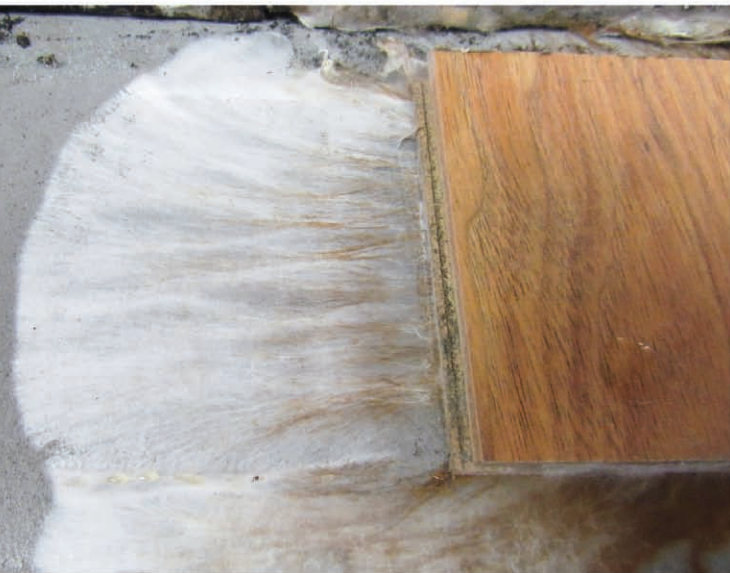
Photo 3. Engineered flooring exemplar with prolific fungal mycelium after 142 days.

to optimal moisture content (surface contact between the flooring and concrete) and consumption of available sugars in the wood. Mold growth was most prolific beneath the engineered flooring exemplars where thick fungal mycelium mats extended as much as six inches across the concrete slab (Photo 3). The least growth was observed among the laminate and hardwood flooring exemplars. A thin foam sheet elevated the laminate flooring exemplars above the concrete surface and prevented direct moisture contact and absorption. Hardwood exemplars cupped in response to moisture absorption and lessened surface contact with the damp concrete. This physical change lessened the area that attained moisture fiber saturation and microbial growth.

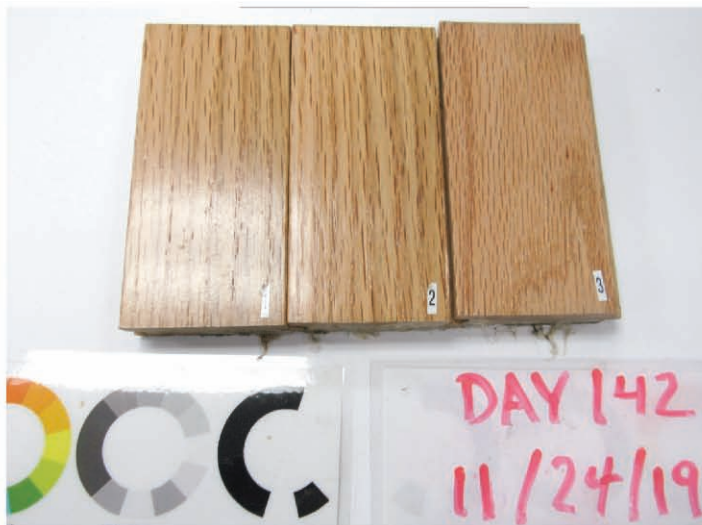
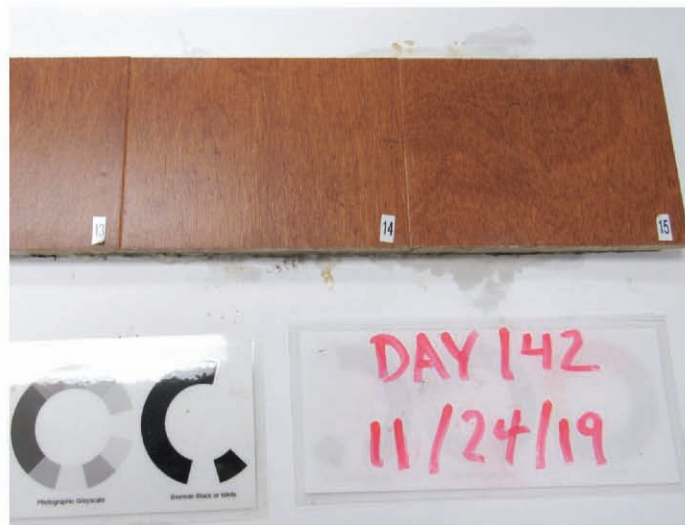
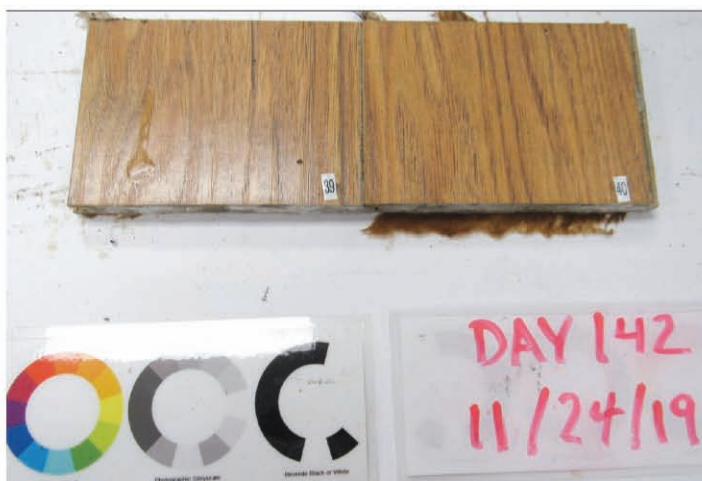
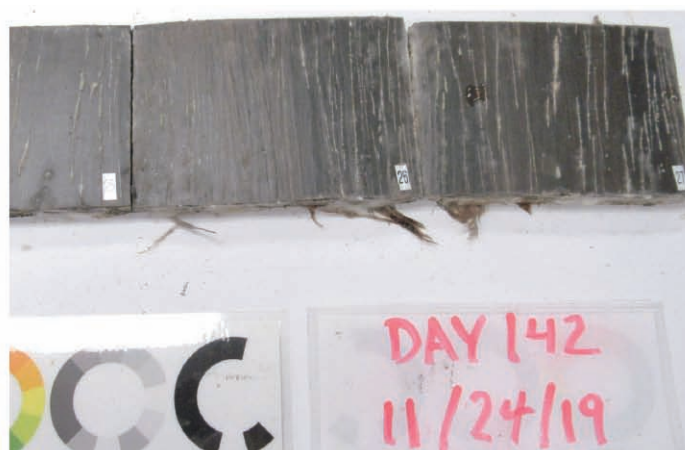
Photo 4. Hardwood flooring after 142 days.

Photo 5. Engineered flooring after 142 days.

Photo 6. Laminate flooring after 142 days.

Photo 7. Bamboo flooring with surface cracking after 142 days.

Nine of 16 flooring exemplars did not exhibit a detectable surface change after three months of exposure to a damp concrete surface. Of the remaining

seven, cupping, surface staining, and surface cracking (bamboo only) would have indicated a change caused by moisture exposure (Photos 4–7).
